TORNADO DAMAGE PATTERNS IN TOPEKA, KANSAS, JUNE 8, 1966

JOE R. EAGLEMAN

University of Kansas, Lawrence, Kans.

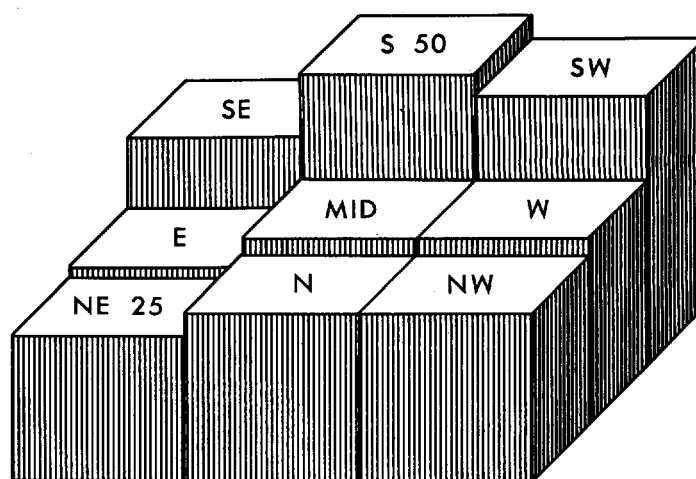
FIGURE 1.—The distribution of unsafe areas in the full basements investigated. Topeka tornado, June 8, 1966.

there was no statistical difference in the distribution of unsafe areas in different parts of the storm. The first-floor investigation would be expected to be the most informative with regard to the dependence of the occurrence of unsafe sections on position within the storm. However, the results of this investigation, to be discussed later, also showed no significant effect on the distribution of unsafe areas of different locations within the tornado funnel. This is encouraging since a person interested in protection from an existing tornado would probably not know what part of the funnel was approaching. It should, therefore, be appropriate to consider the relationship between location within the basement and the total number of unsafe sections obtained by summing those in separate thirds of the storm path. Of the total number of unsafe areas, the south-central section of the basement was unsafe twice as frequently as the northeast section of the basement. Other characteristics of the distribution of unsafe areas are shown in figure 1. The respective percentages are plotted for those sections which had the least and the greatest frequency of unsafety.

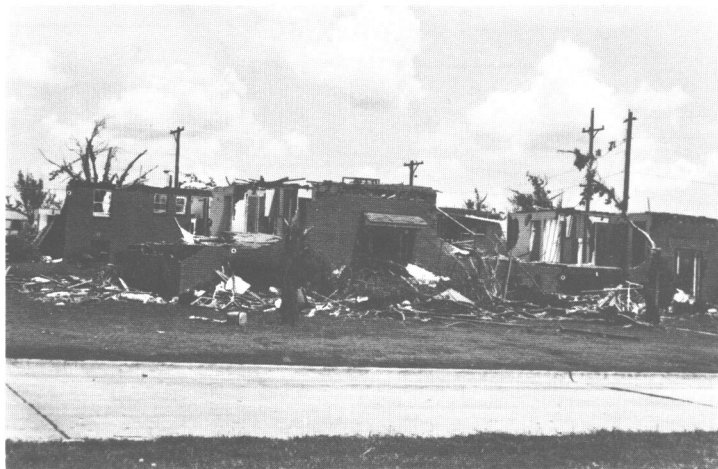
FIGURE 2.—An apartment house battered by the tornado with debris against the south side.

southeastern parts of the damage path were battered by debris carried by the wind. Inspection of many houses in the northwestern part of the storm path did not reveal any similar bombardment of the north sides of the houses. This observation is in agreement with the findings of Budney [5] who made a detailed investigation of the direction of tree fall during a tornado. The damage patterns in his study showed that trees fell in the general direction of the storm movement on both sides of the center of the damage path. Exceptions occurred as the tornado funnel lifted off the ground. In this case a convergent pattern of wind direction was indicated toward the point where the tornado lifted. Figure 2 shows the amount of debris which battered the south side of an apartment house. The impact was sufficient to cave in some of the above-ground portions of the basement wall. Other basements which had south windows were some-

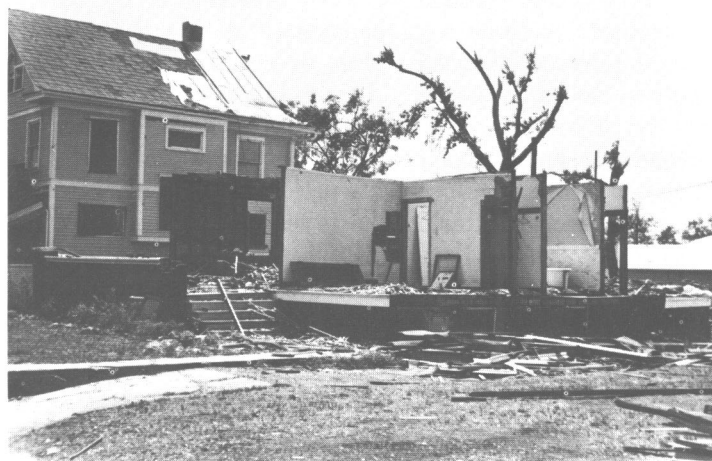
FIGURE 4.—An example of a basement which offered protection in all sections except near the south windows.

Unsafe sections of the basement other than those exposed to the south were subjected mainly to debris falling through the floor. This seemed to be somewhat of a random occurrence and therefore very hard to generalize. Figure 4 is included as an example of the way many of the destroyed houses looked. Persons in the basement and away from the south windows would have been completely safe.

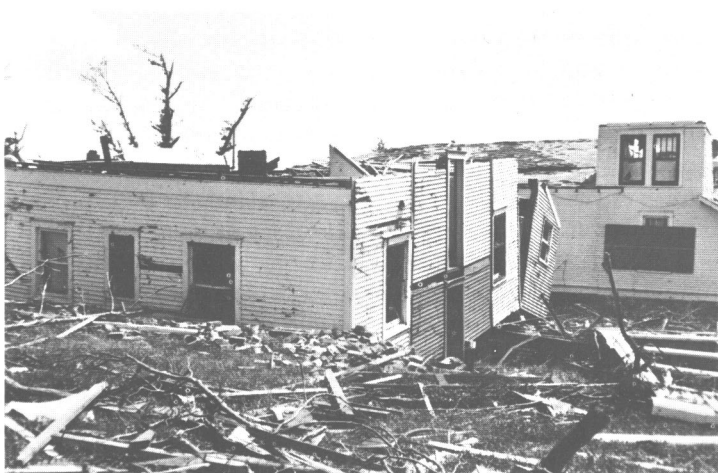
FIGURE 3.—A house sufficiently moved on its foundation so that the southwest corner dropped into the basement.

Figure 3 is another example which was repeated several times. The whole house was shifted toward the northeast enough to allow the southwest corner of the house to fall into the basement. When this happened the north part of the basement had much less debris than did the south. This occurred primarily in houses whose foundations were constructed from concrete blocks or stones.

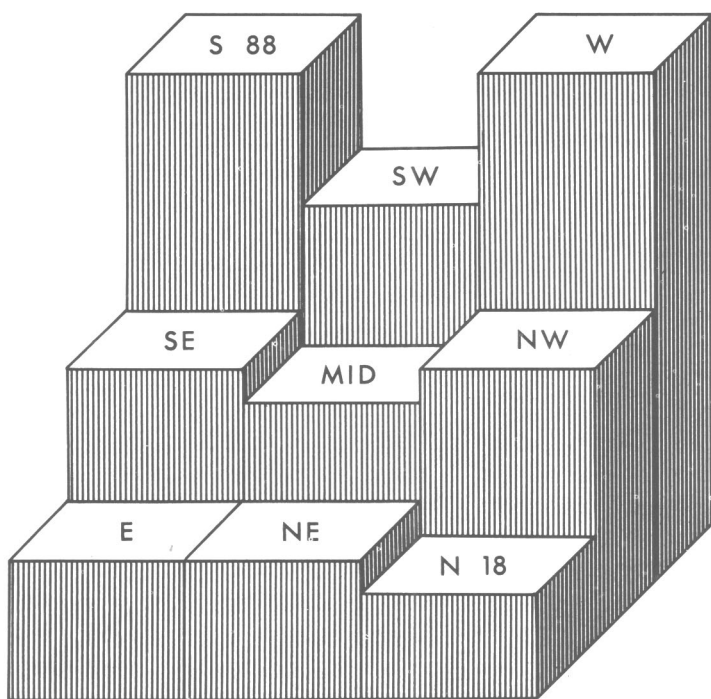
FIGURE 5.—The distribution of unsafe areas in the walk-out basements.

wall was almost entirely submerged. The southwest side had large windows near each end and two doors near the center. The tornado came from the southwest and almost all of these houses were in the middle of its path. The number of houses in the northwest and southeast thirds of the storm path was insufficient for an analysis of the dependence of distribution of unsafe areas on location within the storm. There is, however, no apparent relationship shown in table 2 and since the other basements and the first floor investigation showed no significant association, the total number of unsafe sections will be considered. The distribution of unsafe sections in the walk-out basements is shown in figure 5. Only 18 percent of the houses were unsafe in the north section, while 88 percent of the houses were unsafe in the south and west sections.

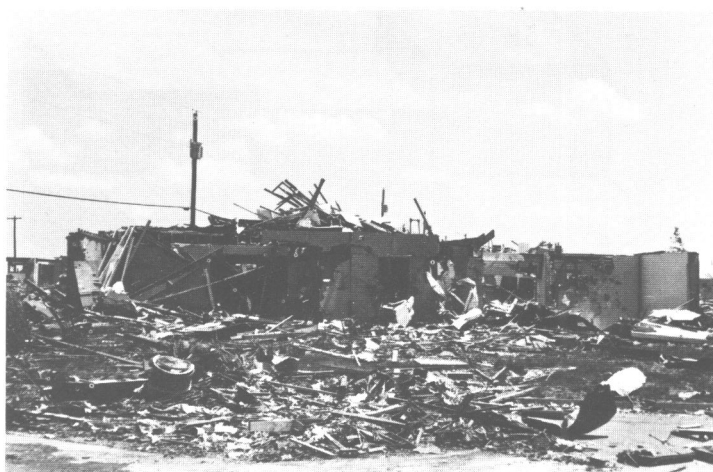
FIGURE 6.—The southwest side of a walk-out basement.

or windows into the south and west sections. The ceiling above the southwest rooms of the walk-out basements was blown away in nearly all cases while it frequently remained over the north section. The southwest and northeast sides of two of these houses are shown in figures 6 and 7.

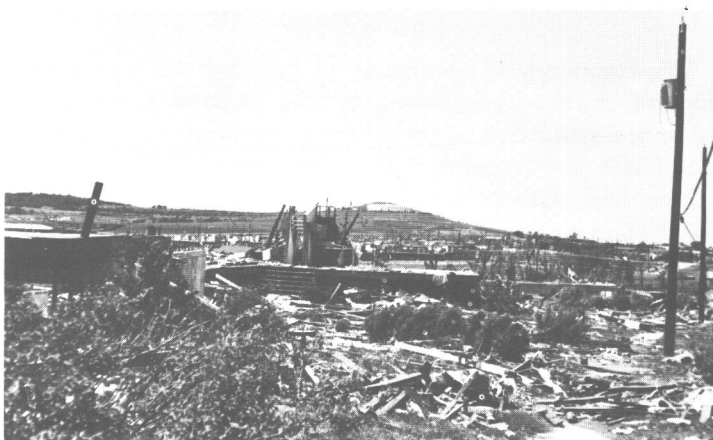
FIGURE 7.—The northeast side of a walk-out basement showing the protected north corner.

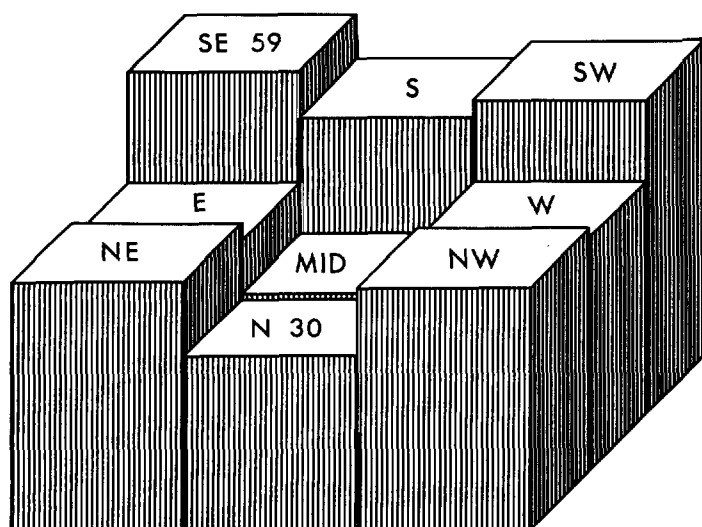
FIGURE 8.—The distribution of unsafe areas on the first floor.

The distribution of unsafe areas on the first floor is shown in figure 8. The southeast section was unsafe most frequently and the north-central area was unsafe less often than other sections. A chi-square analysis of the frequency of unsafe positions, without regard to location within the storm path and assuming an equal probability of safety in all sections of the first floor, gave a value of 16.21 with 8 degrees of freedom. This value was significant at the 95 percent level of confidence. Therefore, an equal

probability of safety did not exist for all areas on the first floor. The most unsafe areas on the first floor were those exposed to the south. The southeast corner was unsafe almost twice as frequently as the north-central section which was only slightly better than the central area of the house.
